AVIATION INVESTIGATION REPORT

A04Q0124

RISK OF COLLISION

NAV CANADA
MONTRÉAL AREA CONTROL CENTRE
12 nm SW OF QUÉBEC/JEAN LESAGE
INTERNATIONAL AIRPORT, QUEBEC
05 AUGUST 2004

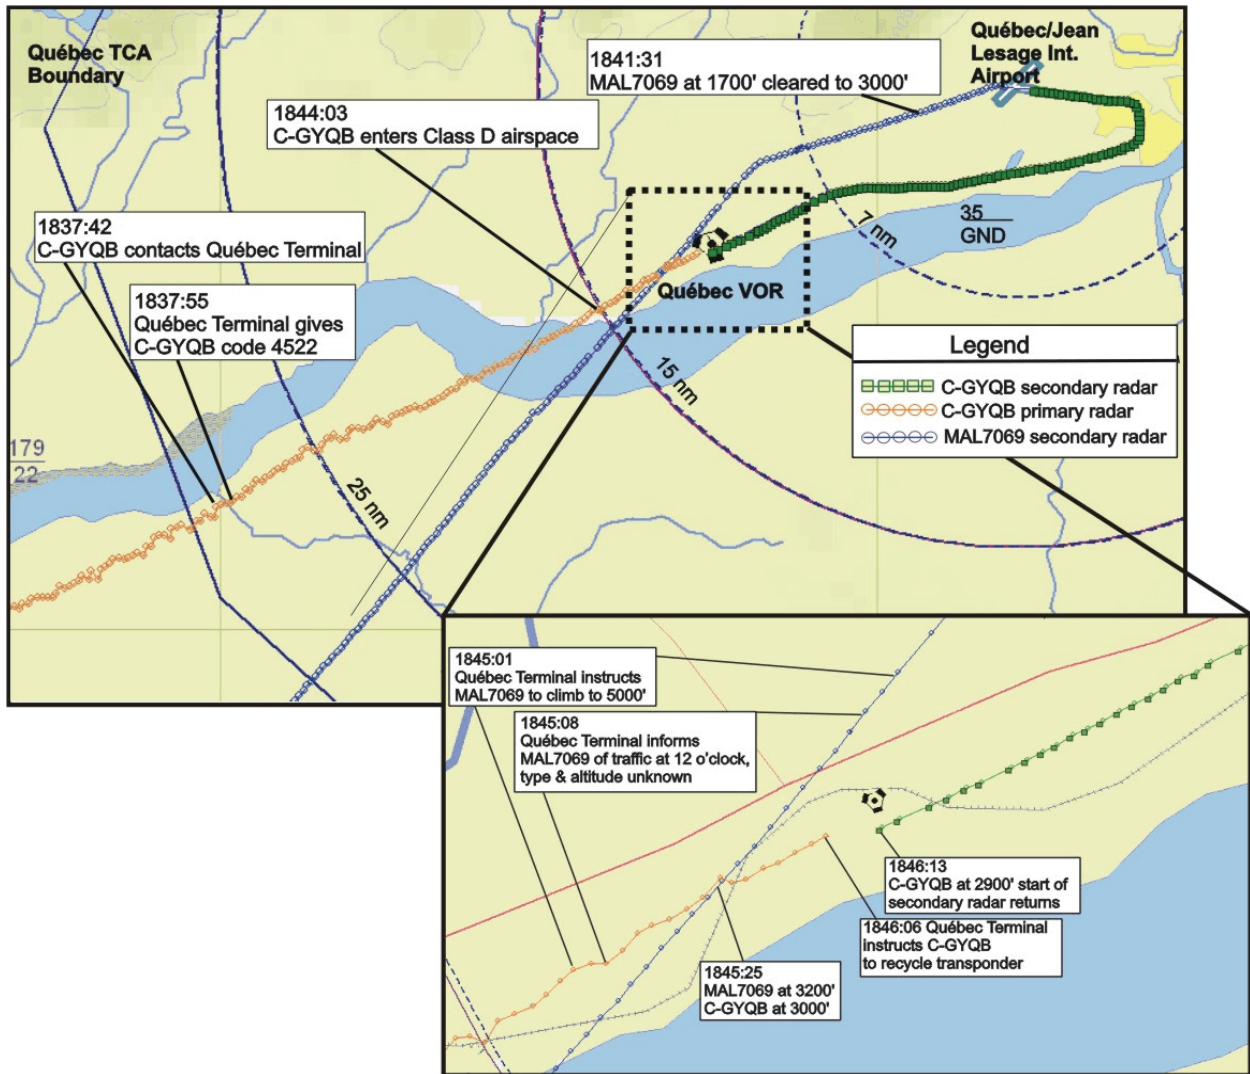
Appendix A – Radar Trajectory

The Cessna 172 was flown by a student pilot who was on a first VFR solo cross-country flight. The routing of the flight was Québec–Saint-Hubert–Trois Rivières–Québec. The first two legs were uneventful, but the take-off out of Trois-Rivières was delayed due to marginal weather conditions. Prior to take-off out of Trois-Rivières at 1800 eastern daylight time,¹ the student pilot did not complete the entire “Line-up” portion of the checklist, omitting to turn the transponder to the altitude encoding position “ALT.” The student pilot made initial contact with the Québec terminal control unit at 1837:42, 28 nautical miles (nm) west of the Québec Airport, while flying at approximately 3000 feet asl² (see Appendix A).

The Québec terminal airspace is comprised of controlled airspace designated either Class B, D, or E in which both VFR and IFR flights are permitted; however, VFR flights require a clearance from air traffic control (ATC) to enter Class B airspace. To the west of the Québec Airport (see Appendix A), Class D airspace starts at 25 nm from 3500 feet to 12 500 feet asl and, within 15 nm, extends upward from 1400 feet. The responsibility for the airspace within 15 nm is divided between the Québec tower and the Québec terminal, with the tower having jurisdiction from 3000 feet and below. The description of the airspace is contained in the *Designated Airspace Handbook* (DAH), and depicted in the *Canada Flight Supplement* (see Appendix B). Both the pilot of C-GYQB and MAL7069 would have had ready access to the latest version of the latter publication in the flight planning phase of their respective flights.
